S-189 Cecil Schrock Farm Near Westover Private c. 1870

Survey No. S-189

## Maryland Historical Trust State Historic Sites Inventory Form

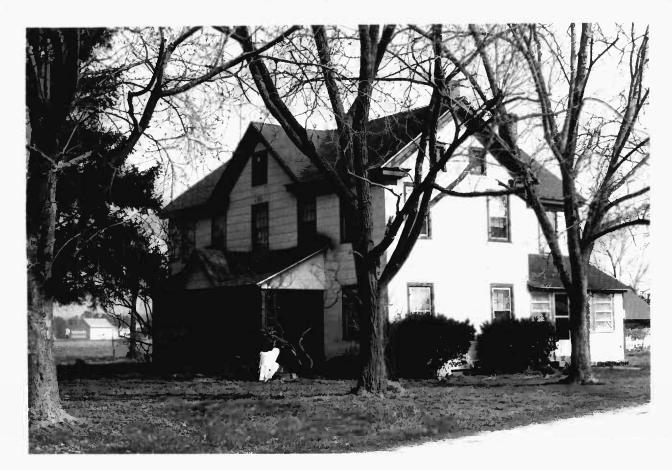
Cecil Schrock Farm
Near Westover, Somerset County
Northwest Elevation
3/84 Paul Touart
Neg./ Maryland Historic Trust

The north (main) elevation is a symmetrical five bays with a center entrance and from each gable. flanking 6/6 sash windows. A screened porch covers the first floor. Centered on the roof stope is a cross-gable with a smaller sash window.

Both gable ends have two 6/6 sash on each floor that flank the interior end stack.

Two floor-pane sash light the attic. The eaves are extended.

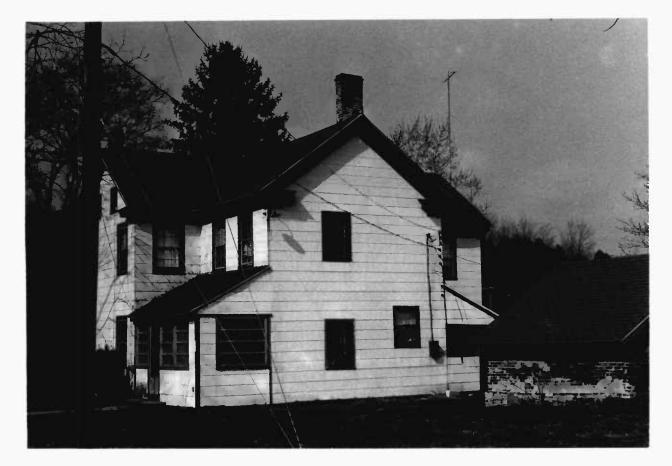
Cecil Schrock Farm
Near Westover, Somerset County
South Elevation
3/84 Paul Touart
Neg./Maryland Historic Trust

The south elevation of the house is largely covered by the "T" service wing with shed porches to each side. The rear wing is similarly lighted by 6/6 sash windows.

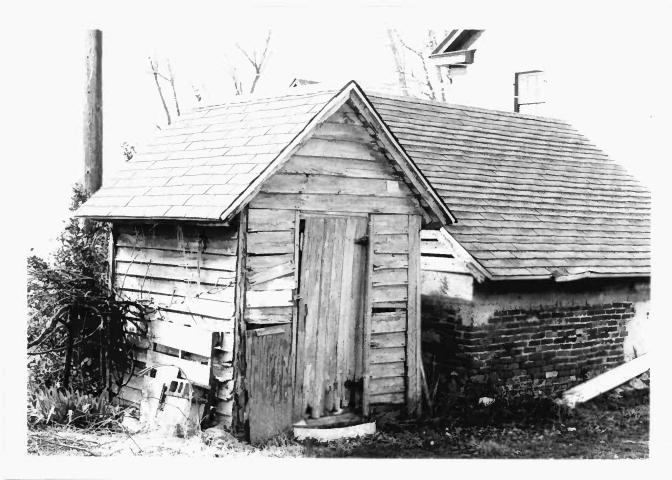
Cecil Schrock Farm
Near Westover, Somerset County
Smoke House - East Elevation
3/84 Paul Touart
Neg./MD Historical Trust

Directly behind the dairy building is a small one-bay by one-bay frame smokehouse with a gable-front roof. The structure is covered with weatherboards and pier on the east side by a board door. The interior has been blackened.

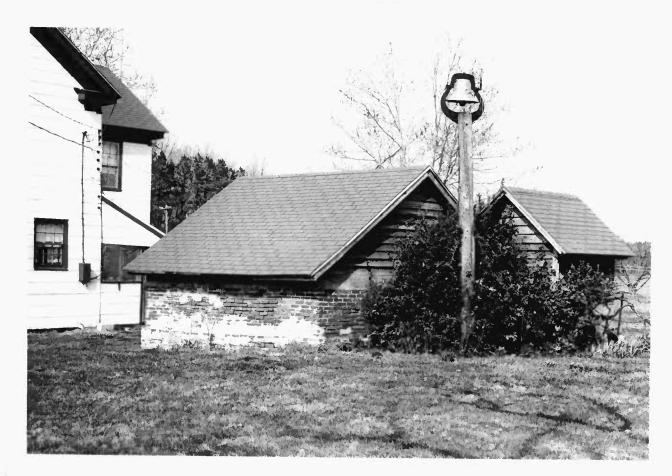
Cecil Schrock Farm
Near Westover, Somerset County
Dairy-West Elevation
3/84 Paul Touart
Neg./ Maryland Historic Trust

Standing behind the kitchen is the remnant of a brick dairy building. The common bond brick walls appear to have been reduced in size and capped with concrete. A simple gable-front roof of early 20th century consturction covers the building. At the base of the structure is a projecting water table.
